R E P O R T

WATER POLLUTION SURVEY

VILLAGE OF DRAYTON

Dates of Sampling: November 20-21, 1972

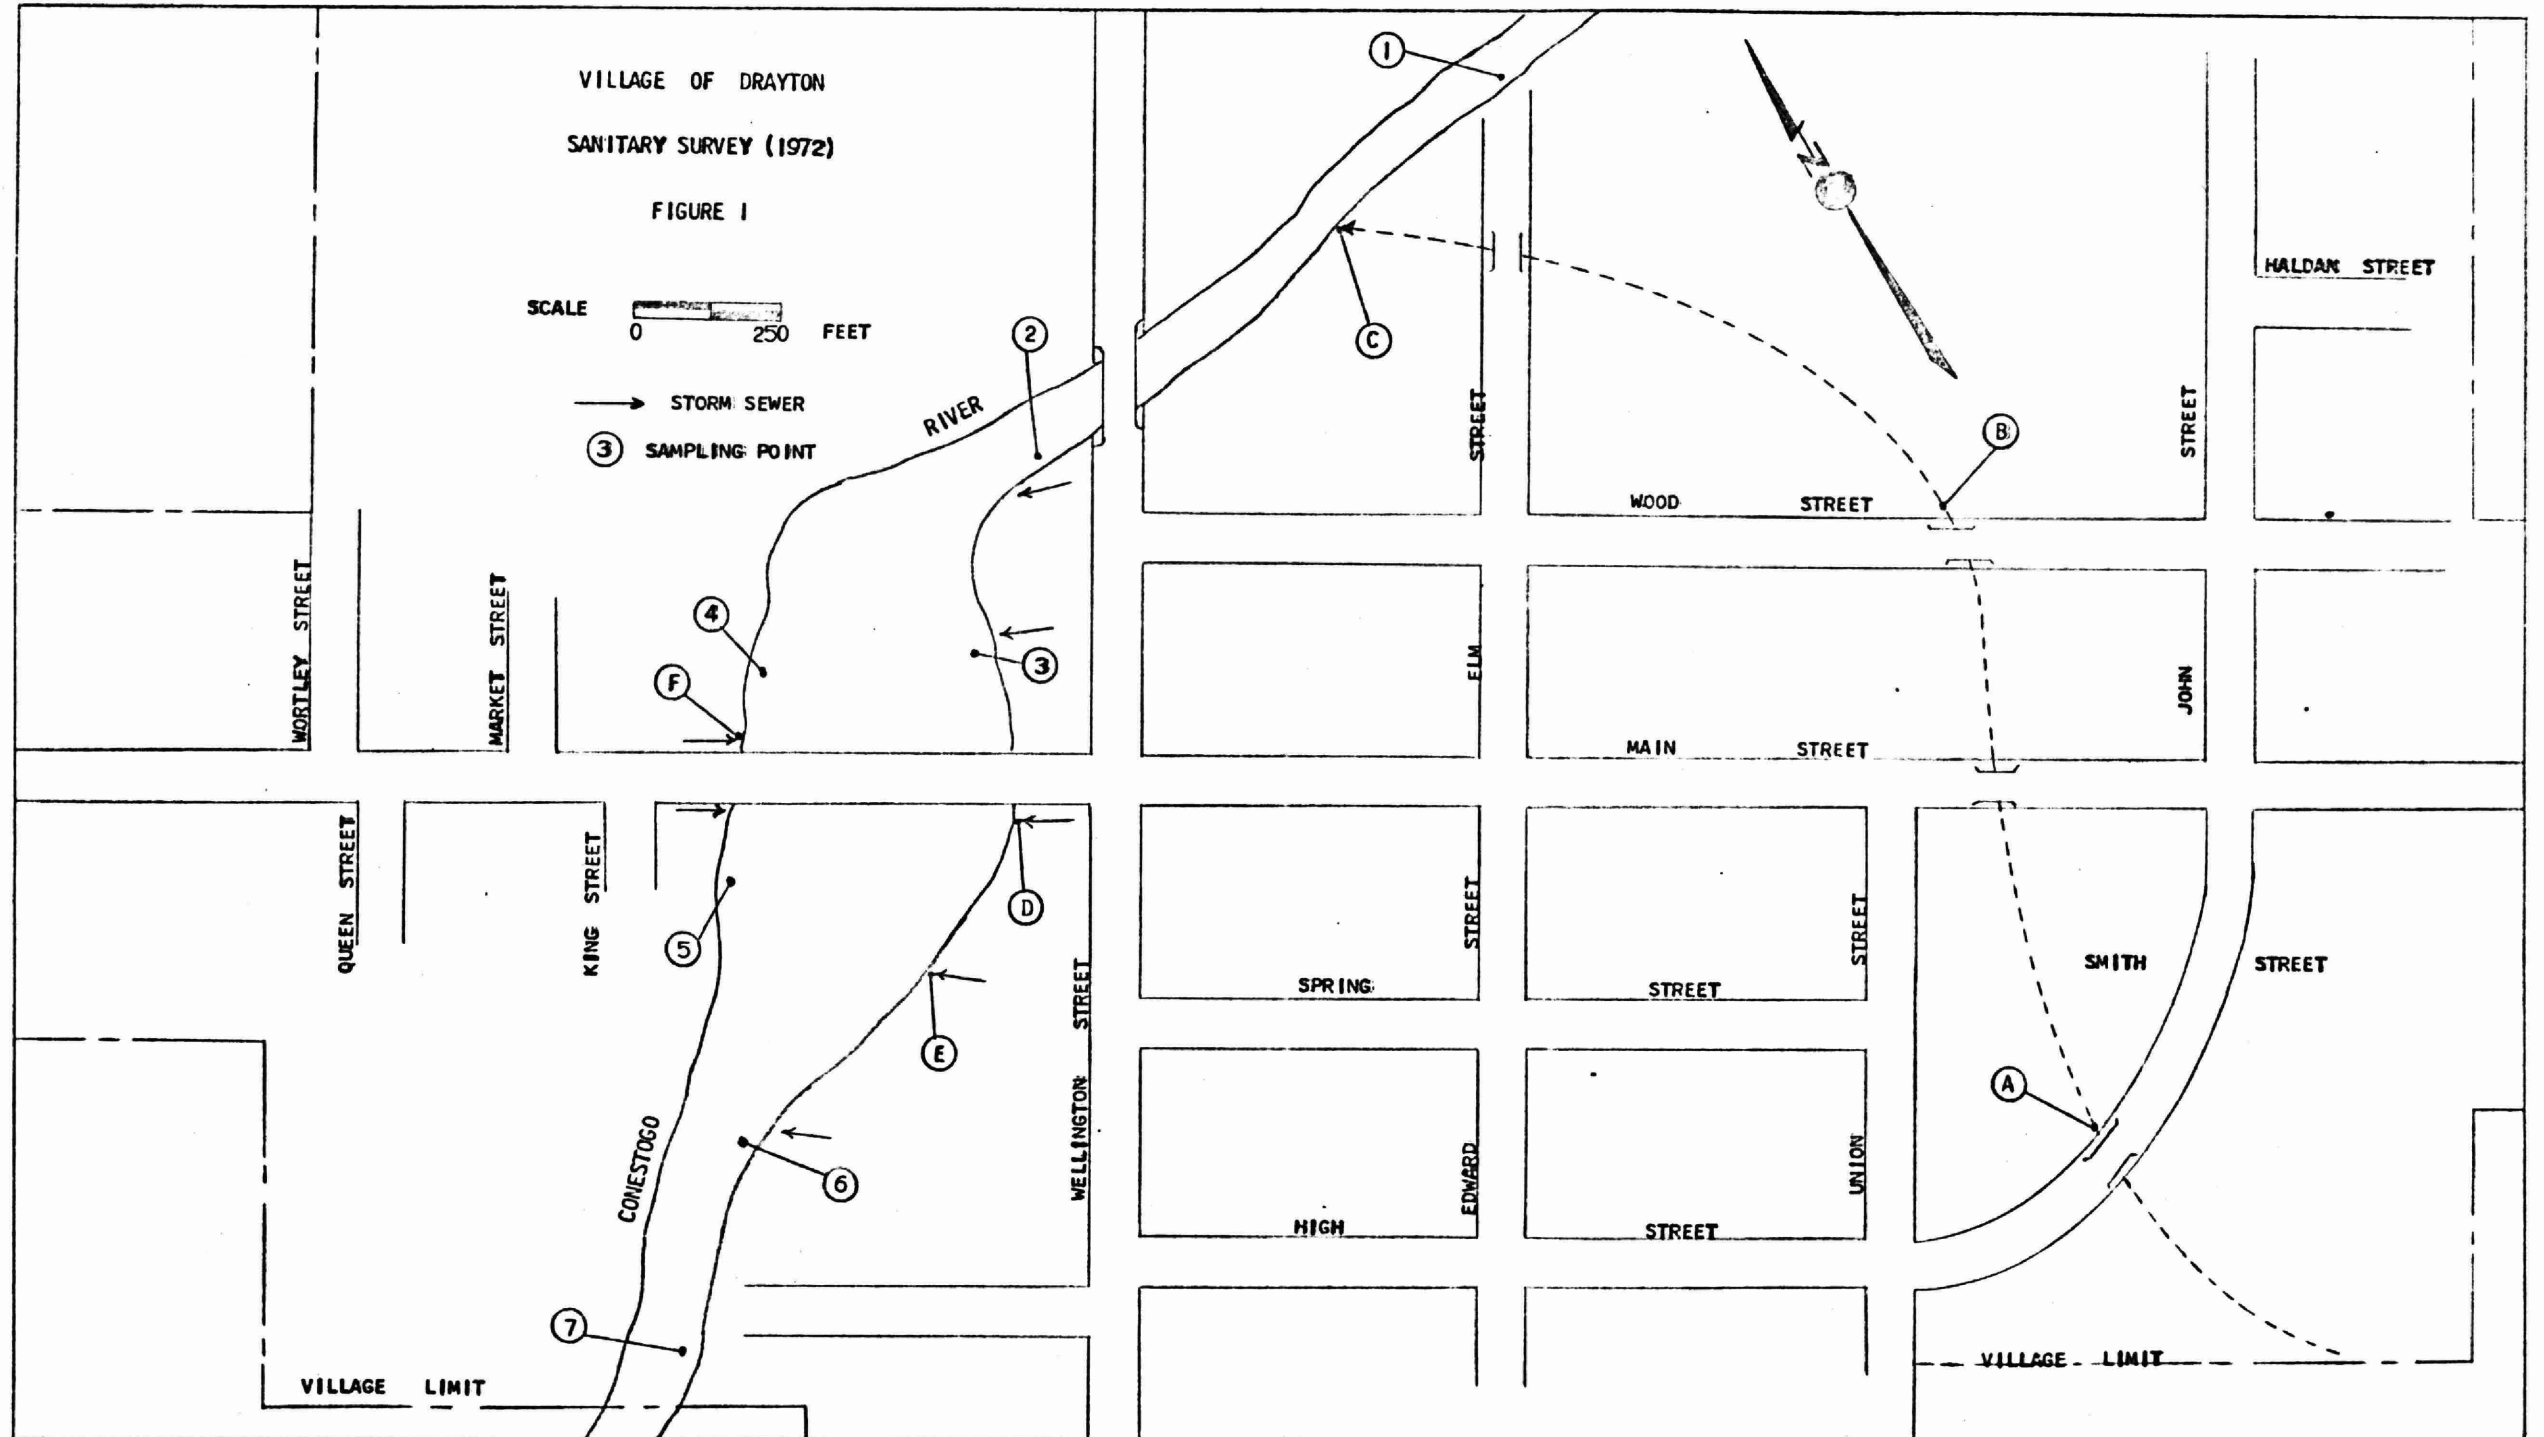
FIGURE 1

The sample points A, B, and C are from a drainage ditch which runs through the eastern section of the Village as shown in Figure I. The sample analyses results showed total and fecal coliform bacteria in both significant and increasing values between points A and B. The bacteriological levels decreased between points B and C, and the Biochemical Oxygen Demand values decreased progressively along the length of the ditch. Such decreases are probably due to melting snow dilution and natural oxidation. The area around the outfall showed signs of decomposing organic matter and emitted a septic odour, indicating the presence of domestic waste in the ditch. Chemical sample analyses from the same points also confirmed this, as shown in Table I.

Sample points D and E were from storm sewers found to be discharging an effluent on the east bank of the Conestogo River. The analyses of the bacteriological and chemical samples of the effluent from the Main Street storm sewer outlet, Point D, indicate by means of high bacteriological, Biochemical Oxygen Demand, and Suspended Solids levels, that domestic wastes were present in the discharge from the storm sewer. The effluent temperature was notably warmer than the air temperature at the time, also indicating that the storm sewer contents can be attributed to other than natural storm sewer discharge. Sample point E, from the second drain outlet south of the Main Street bridge, similarly indicates the discharge of domestic waste. The area around both outfalls showed signs of decomposing organic matter.

Sample point F was from a drain outlet at the north-west corner of the Main Street bridge. The analyses results of the bacteriological and chemical samples of the drains discharge indicate the presence of domestic wastes.

The Main Street storm sewer, which receives flow from the Wellington Street storm sewer, was found to be the largest contributor of domestic wastes, in both flow and in strength, to the Conestogo River.

It is recommended that the Village of Drayton take immediate action to eliminate all domestic waste discharges to the Conestogo River by the provision of a municipal sewerage system.
